## **Chapter 3**

# **THE EMERGENCY INCIDENT RESPONSE**

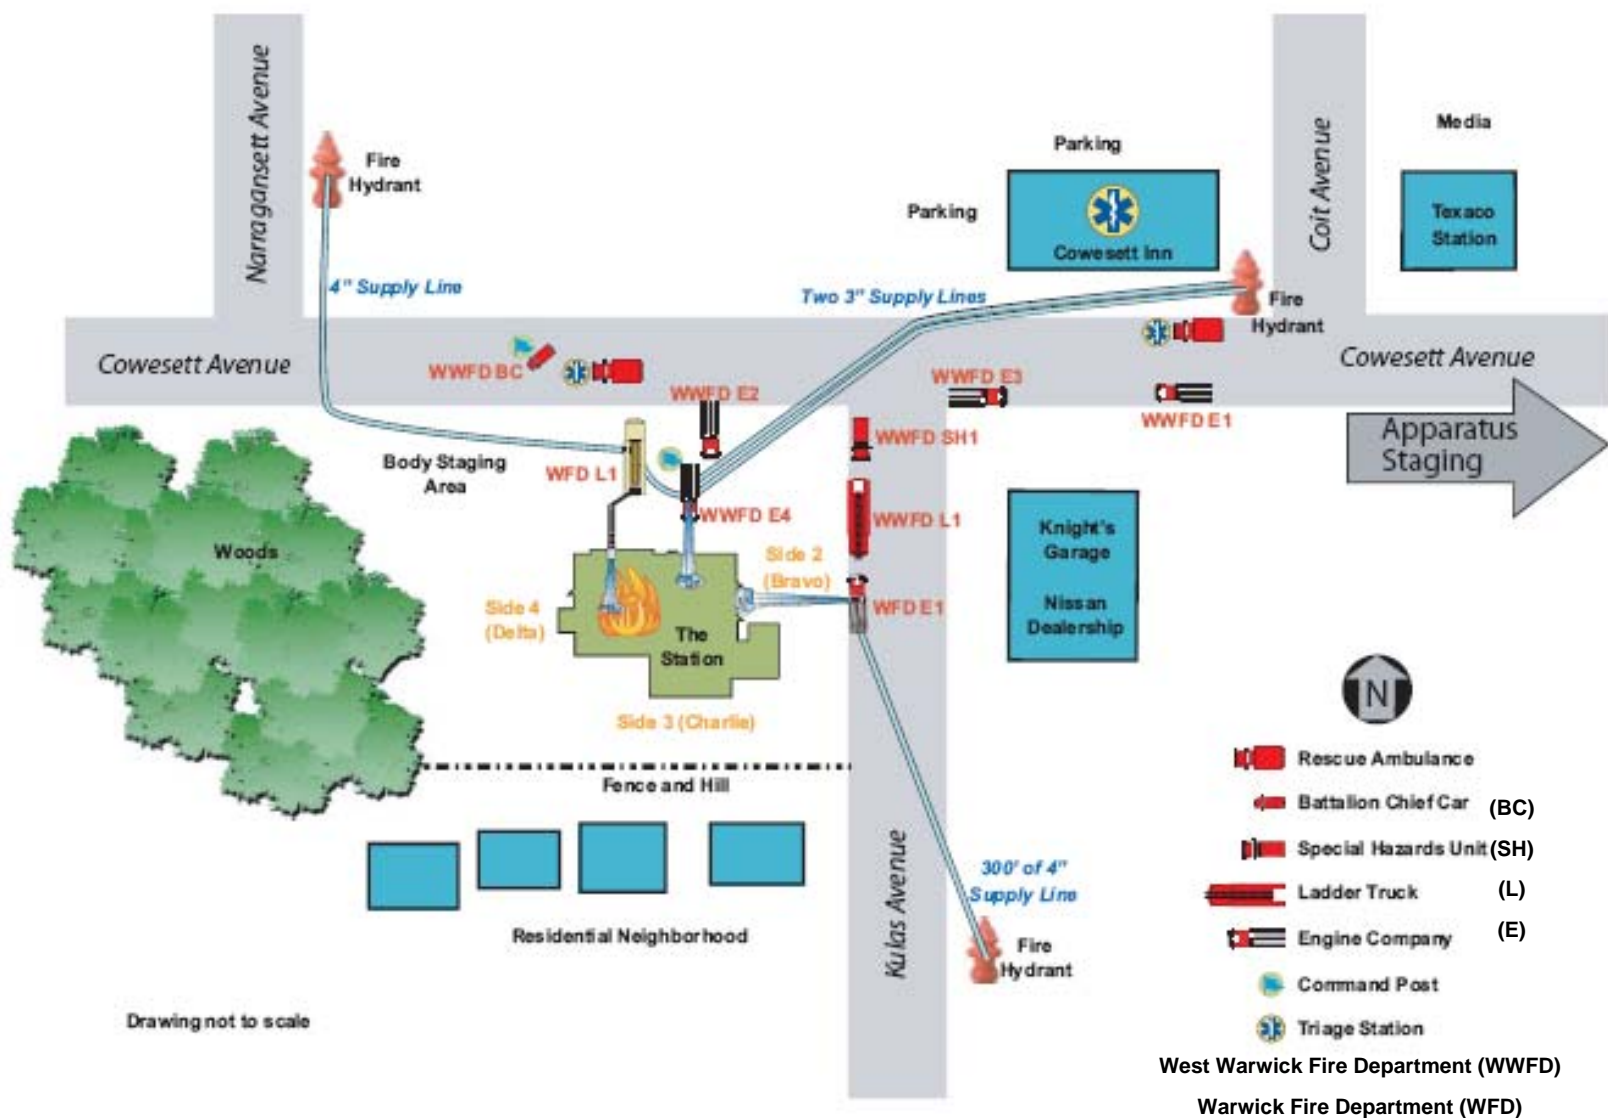
**Figure 3-1. Schematic of primary apparatus deployment**

Figure 3-1 shows the layout of the fire ground during the fire attack and suppression activities. The initial attack was mounted by WWFD's first unit, Engine 4, approximately 6 ½ minutes into the fire with the advance of a 1 ¾" line to the main entrance of the structure and the primary victim cache, and continued until the unit's on board water supply was exhausted. While the two, 3" supply lines to the front of the structure were being laid and charged, rescue efforts continued along the building's north face, through both the broken windows and exits. However, these efforts were pursued without the benefit of protective hose lines and were substantially hampered by the rapid fire propagation, radiant heat and heavy volumes of smoke discharge from the structure.

Once the two 3" supply lines to Engine 4 were established approximately 10 minutes after their arrival, an apparatus mounted deck gun/master stream operation was initiated from WWFD's Engine 2 and additional hand lines deployed at the front and to the west side of the structure.

The incident area had immediate access to a municipal hydrant system to support fire ground operations. Although positioned short distances away (see Figure 3-1), the incident site had expedient access to three hydrants, all of which were utilized.
